HISTORIC AMERICAN BUILDINGS SURVEY

FORT LEAVENWORTH, BUILDING # 17
(OLD POST COMMANDER'S RESIDENCE)

HABS NO. KS-53-N

Location: 20-22 Sumner Place, Fort Leavenworth, Leavenworth County, Kansas

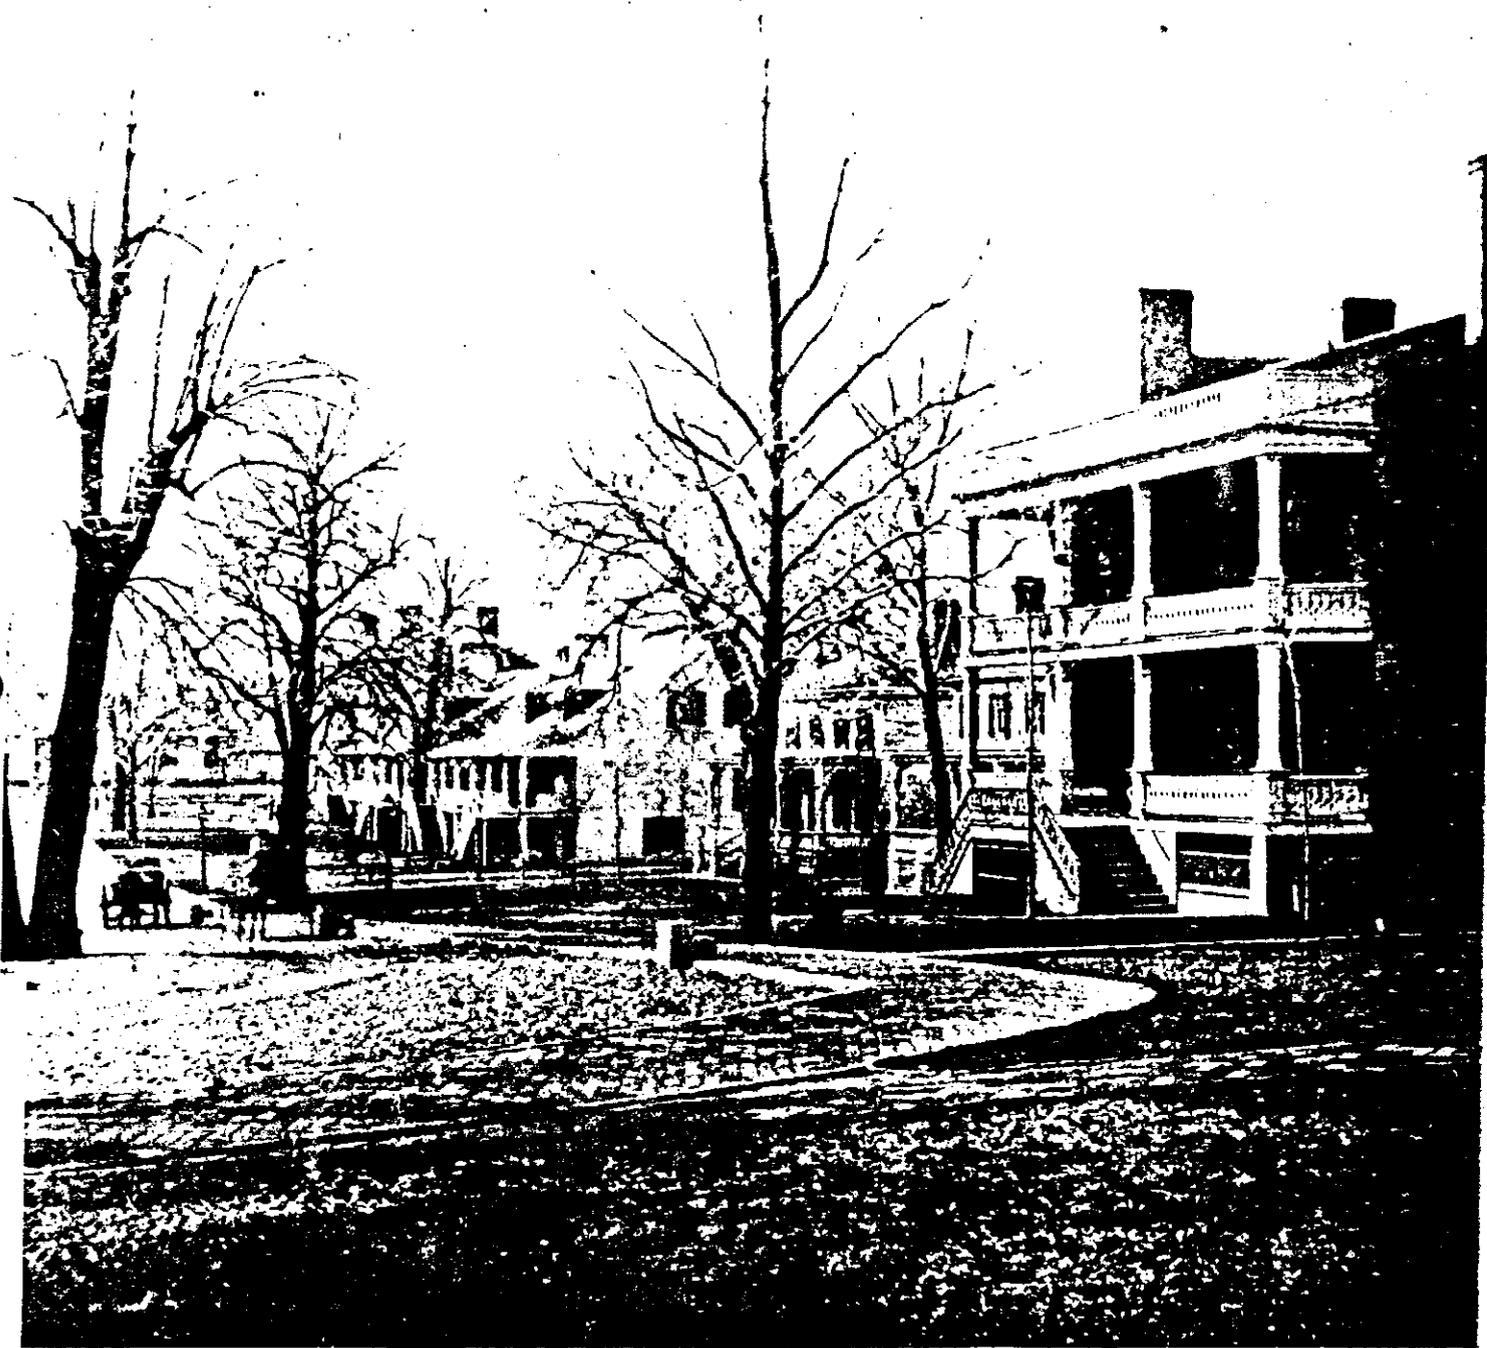
1. Summer Place, north
Parade Grounds, circa. 1865-70

Summer Place 1865-1870 North

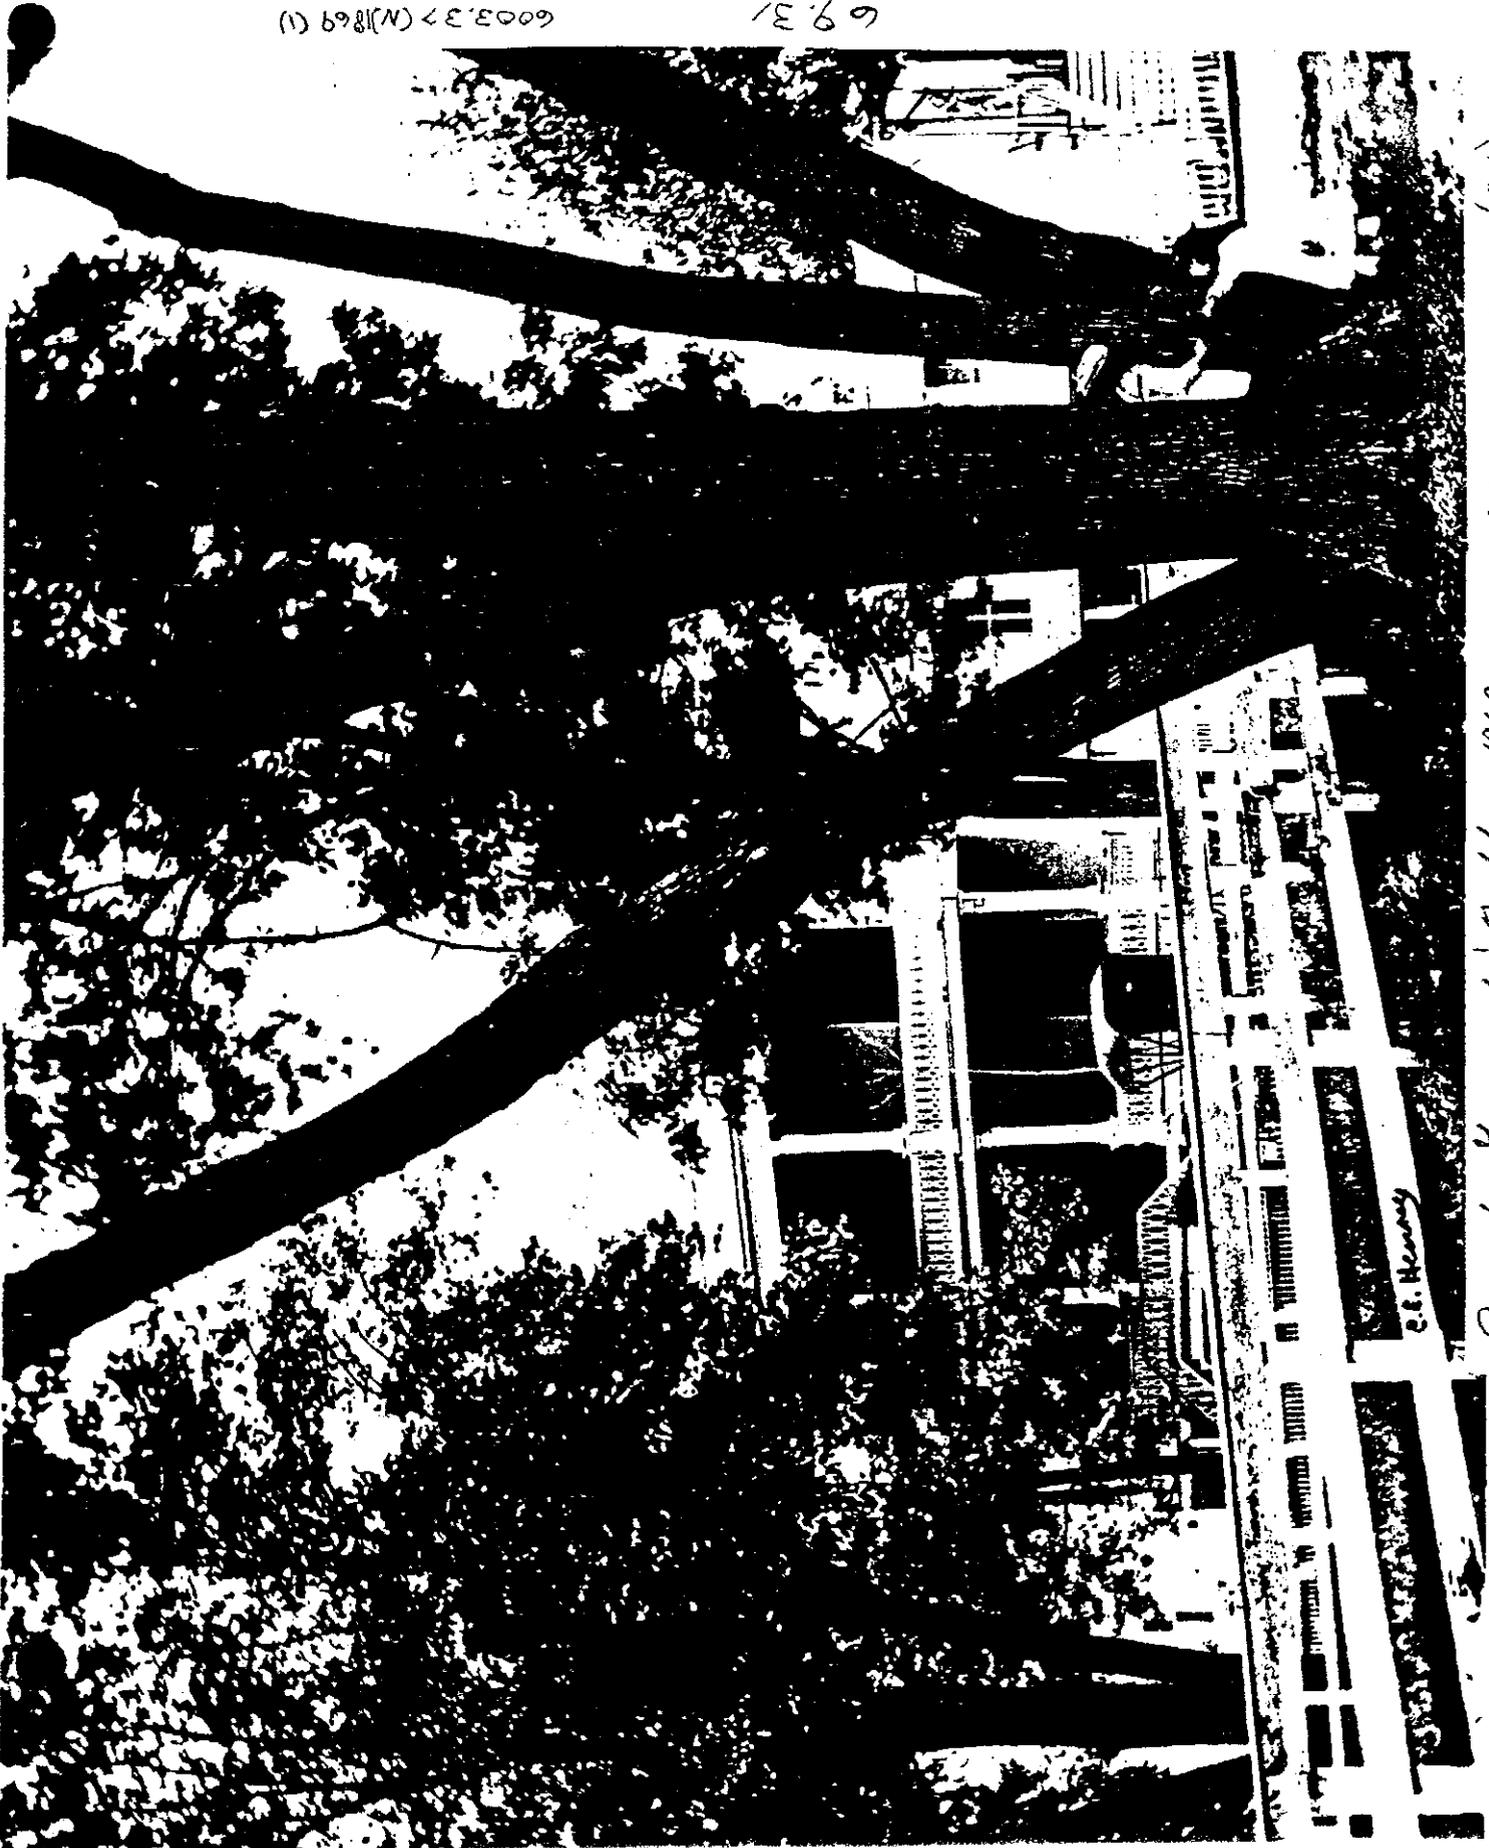
Parade Grounds North 1869 69.31 6003.37 (28)

Between 1869 and about 1881 (see 1869 and c. 1878-81 historical photographs, Supplemental Material, Items # 2 & # 3), several alterations were made. Originally, six over six double hung sash windows had appeared in both the first and second stories of the facade. Apparently during the 1870's, the first floor windows were lowered to floor length and given triple-hung sashes. The present, six-faceted bay windows were added during the same period to the basement and first story of the west and east elevations. The balustrade, or parapet built in c. 1855-56 above the cornice of the second tier of the facade verandah was removed. Two other c. 1878-81 historical photographs (Items # 3 & # 4) show that at some point a frame, clapboarded addition had been made to the rear of the residence, enclosing the first story tier of the rear verandah and extending beyond it slightly to the north and west.

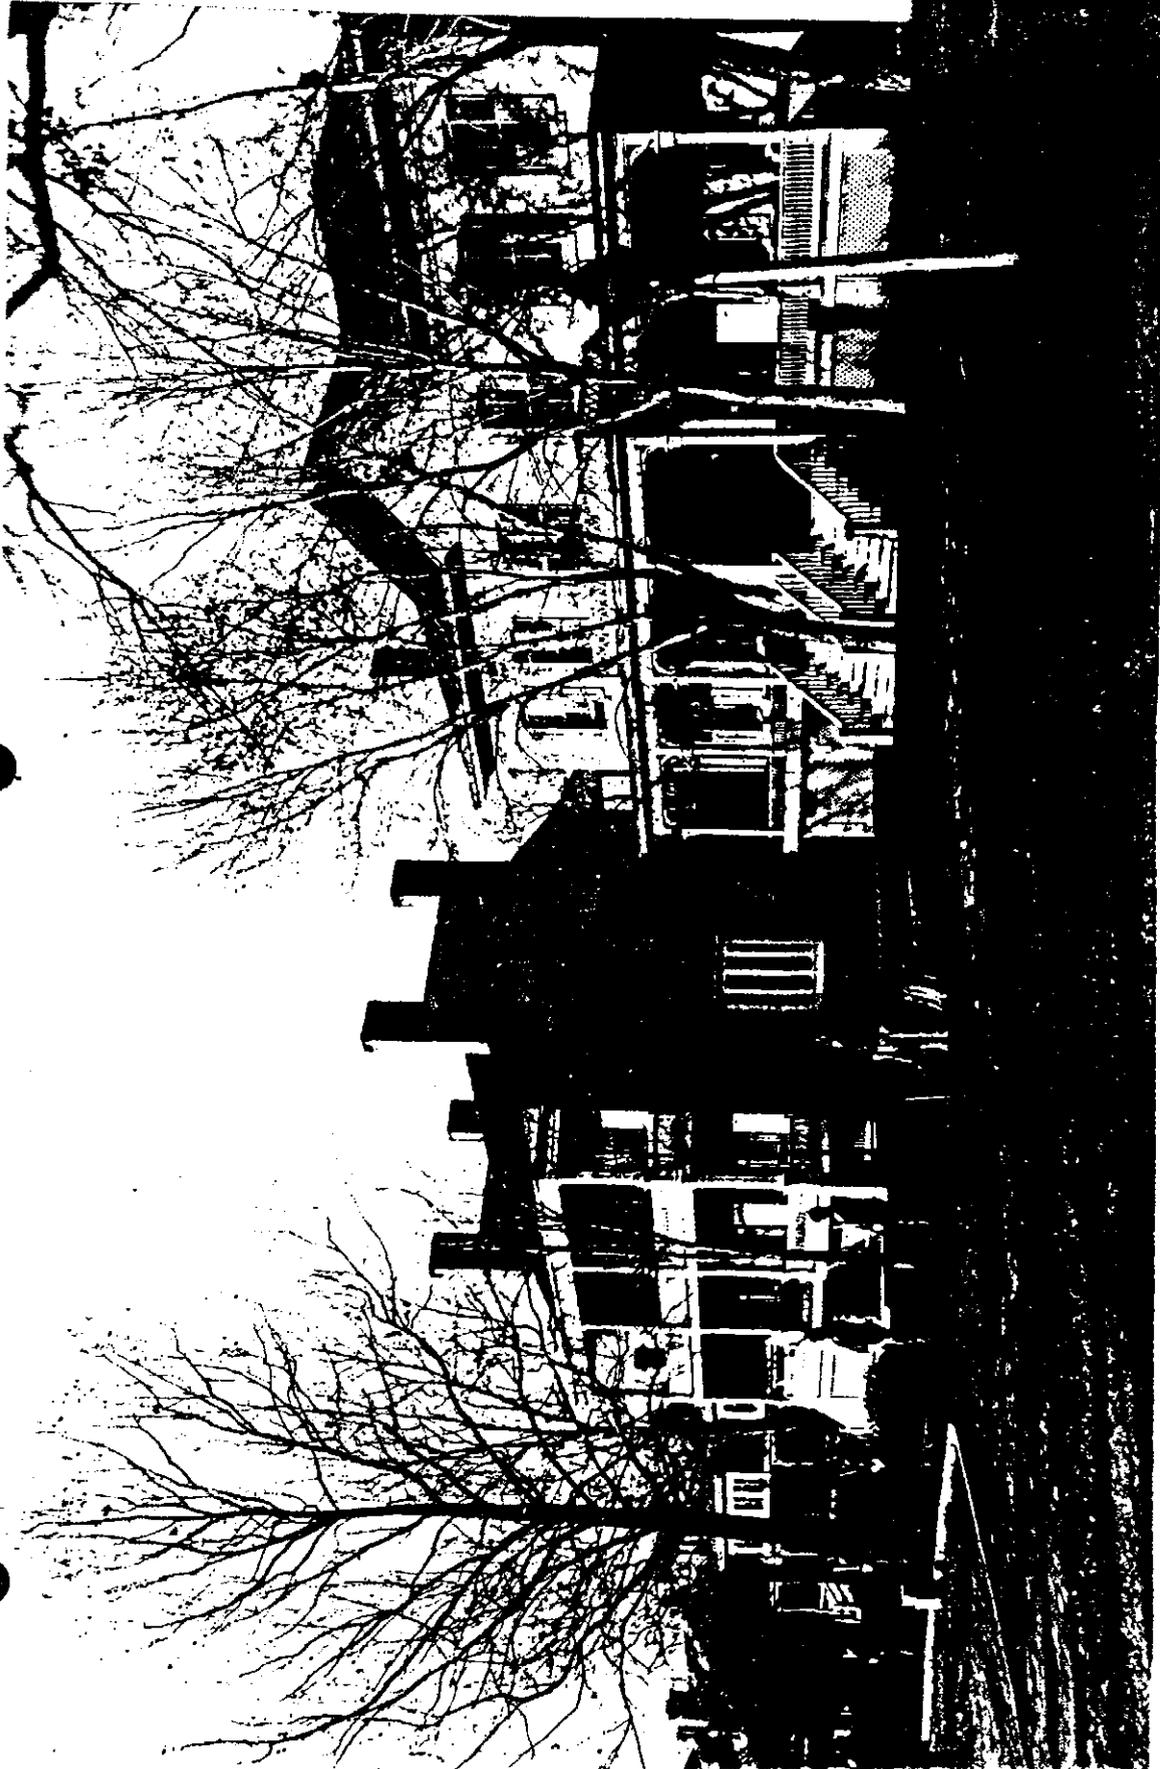
3. View from Building # 17,
circa. 1878-81

Quarters--north side garrison parade grounds.

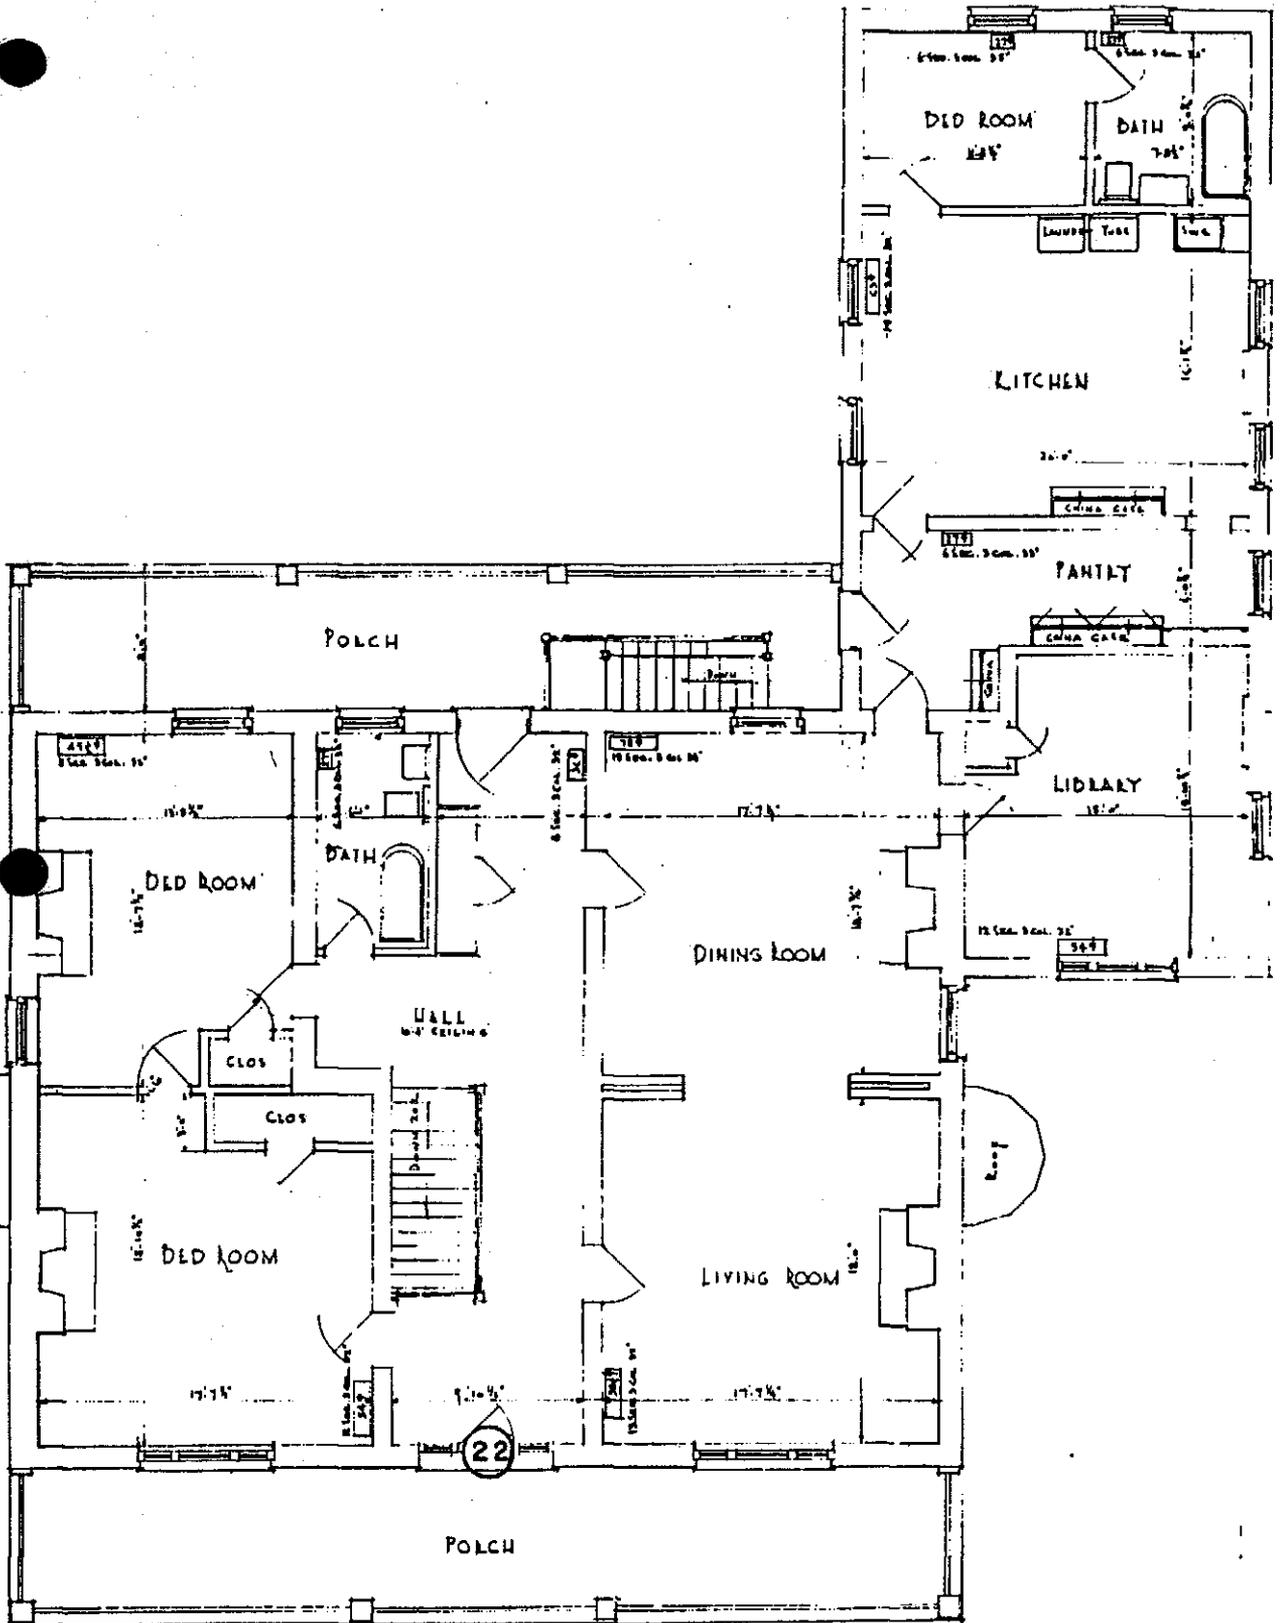
7. Second floor plan

SECOND FLOOR PLAN

Larger changes occurred between 1905 and 1915, during the period of large scale expansion and reconstruction that accompanied the growth of the Army Service Schools at the post. A comparison of a c. 1905 photograph of the building with one taken about 1915 illustrates what transpired. To convert the first and second floors into separate field officer quarters, the previous single main entrance with its side lights, five-light transom, and eight-paneled door was replaced by the present double entrance of two doorways flanking a paneled central section. On the second story of the facade, the original central bay of a six over six window with side lights was replaced by the current doorway. Inside, the original interior stairways were removed from their position at the northwest corner of the central stairhall on each floor. To make the quarters separate from each other, a private stairway was constructed to the second story from the west entrance on the facade. Bathrooms were built in the space on the first and second floors formerly occupied by the interior stairways (see present floor plans, Supplemental Materials Items # 6 & 7).

- c. Second floor plan: The plan of 22 Sumner is nearly identical to that of 20. The stairway from below is located at the center of a U-shaped stair hall, rather than at the south end. In all other respects, the circulation pattern and room designation are the same.
